Long-term planning efforts to address landings in Brewster

Coastal Adaptation Project

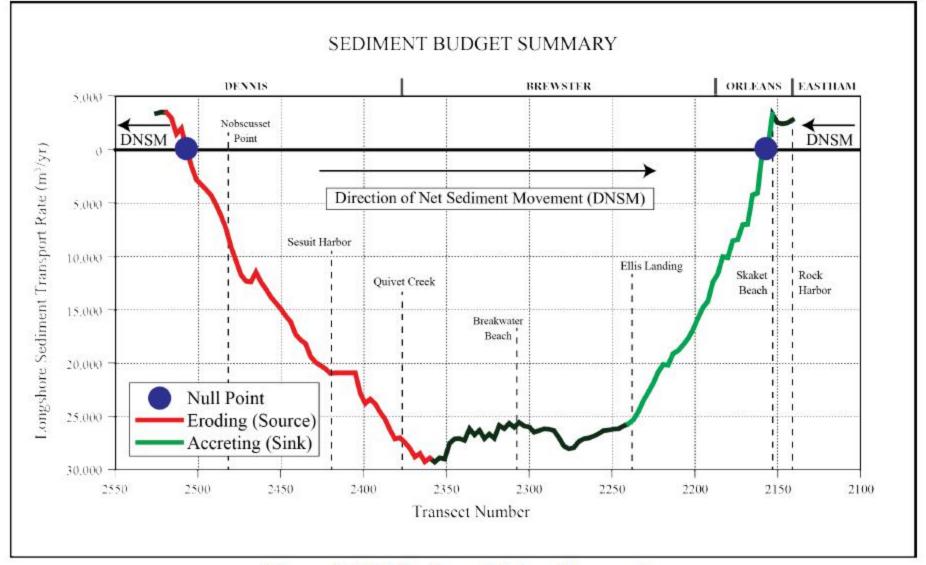
Sediment Budget study

Figure 8: Distribution of Q for all transects.

- Measuring the volume, rate and direction of sand movement of Brewster's entire coast, i.e. a sediment budget
- Photo-documenting and habitat monitoring at each coastal Landing;
- Engineering evaluation of each Landing and beach
- Developing short and longer term management recommendations based upon condition of landing, sand movement and the natural systems surrounding each location.
- Designing a major coastal retreat design for Breakwater, one of the largest beach parking lots, including restoring former parking areas to coastal dune and green stormwater control;
- Designing for a measured retreat at two landings, [Ellis Landing and Mant's Landing] that have suffered significant repetitive losses

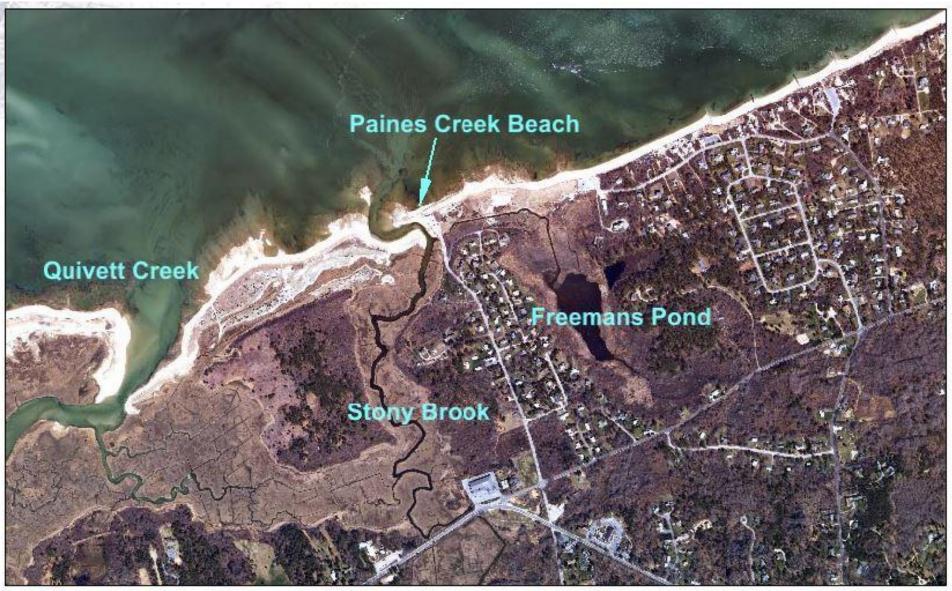
Figure 1. 2005 aerial of Paines Creek Beach, Brewster, MA (Mass GIS).

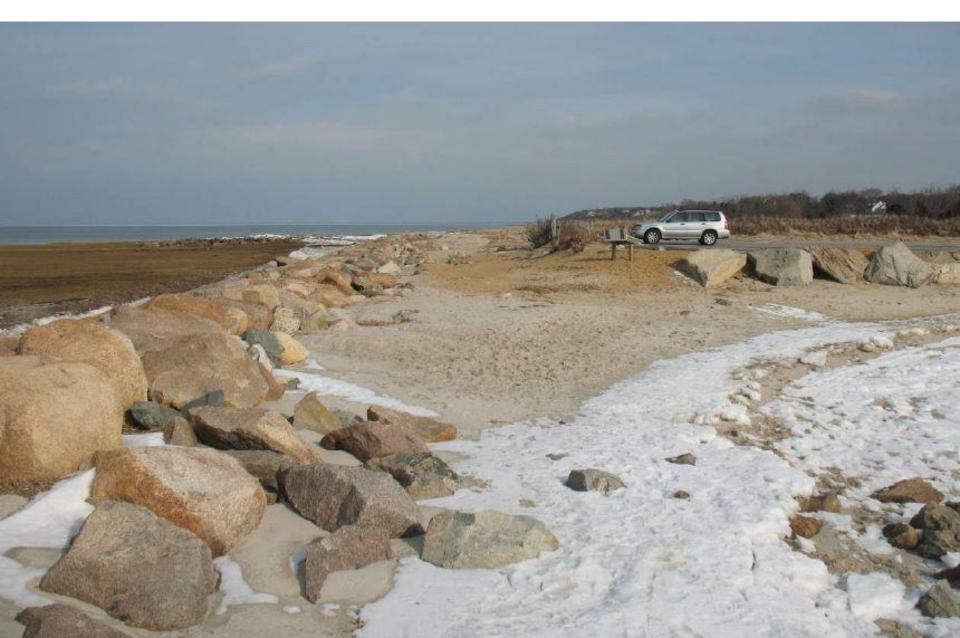
Figure 7. Progressive erosion occurring at western end of Paines Creek Beach parking area. Panel (a) is photo taken on February 13, 2009 (looking southeast) while panel (b) shows same view taken on March 26, 2009.

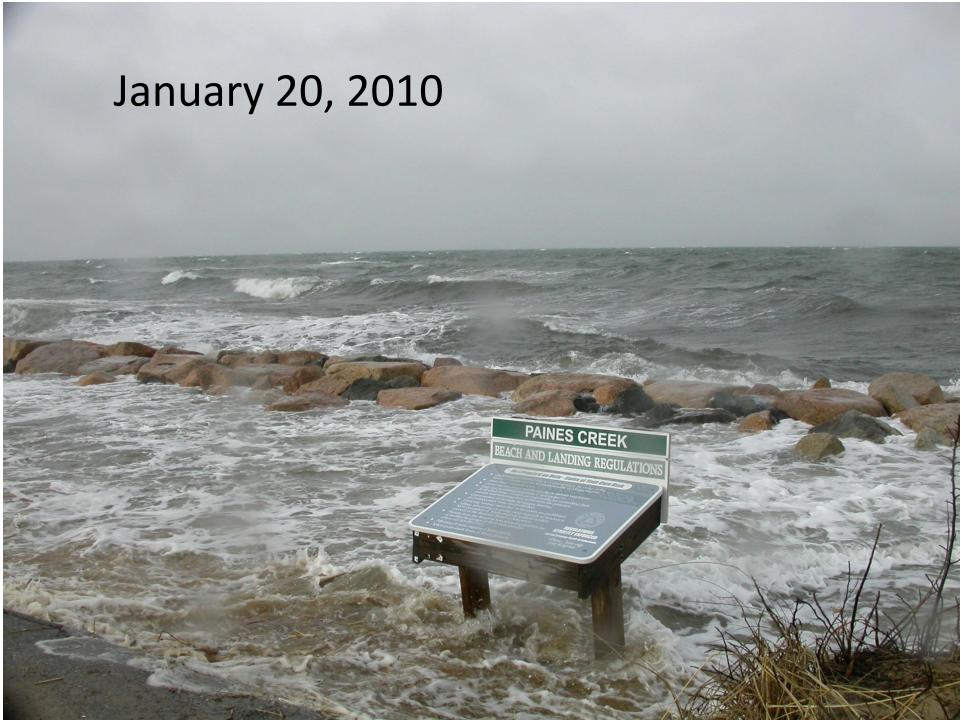
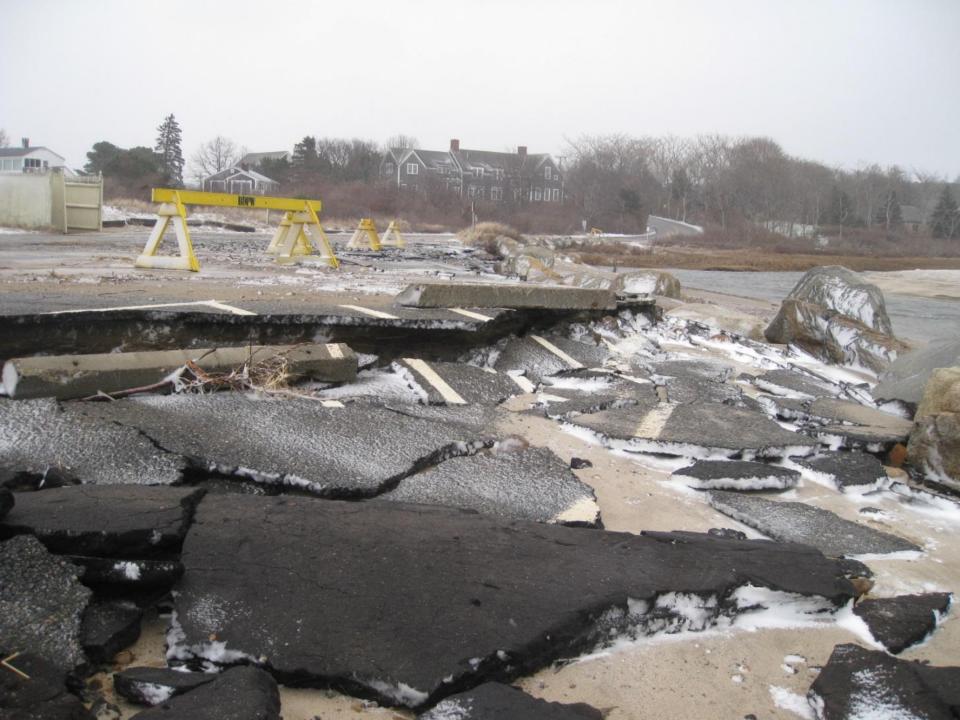
Stormwater erosion from parking area at southeast side on March 14, 2010.

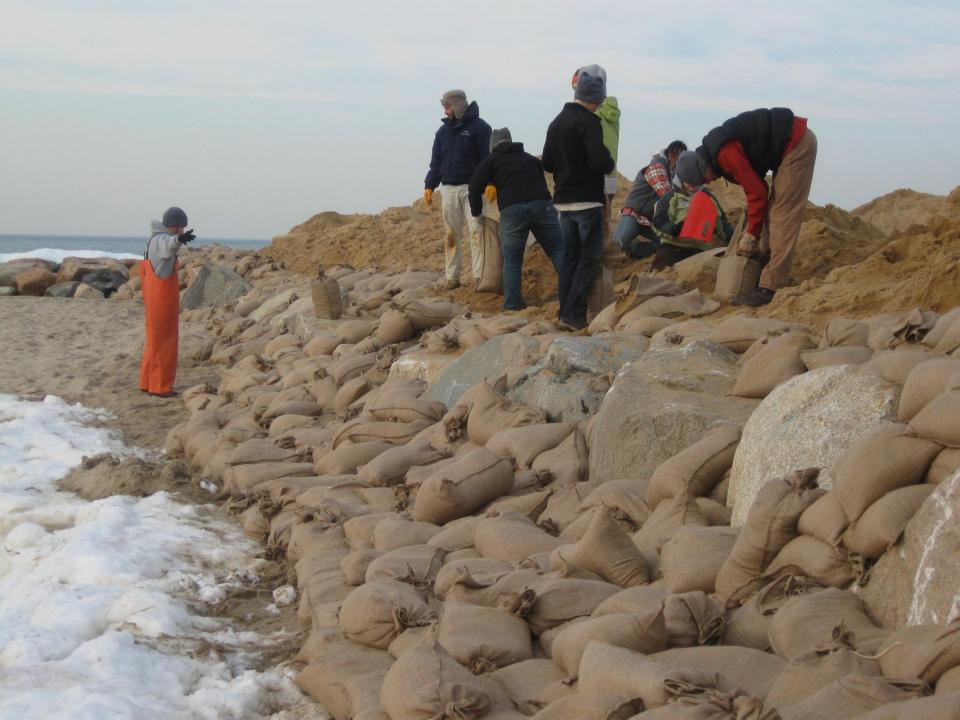
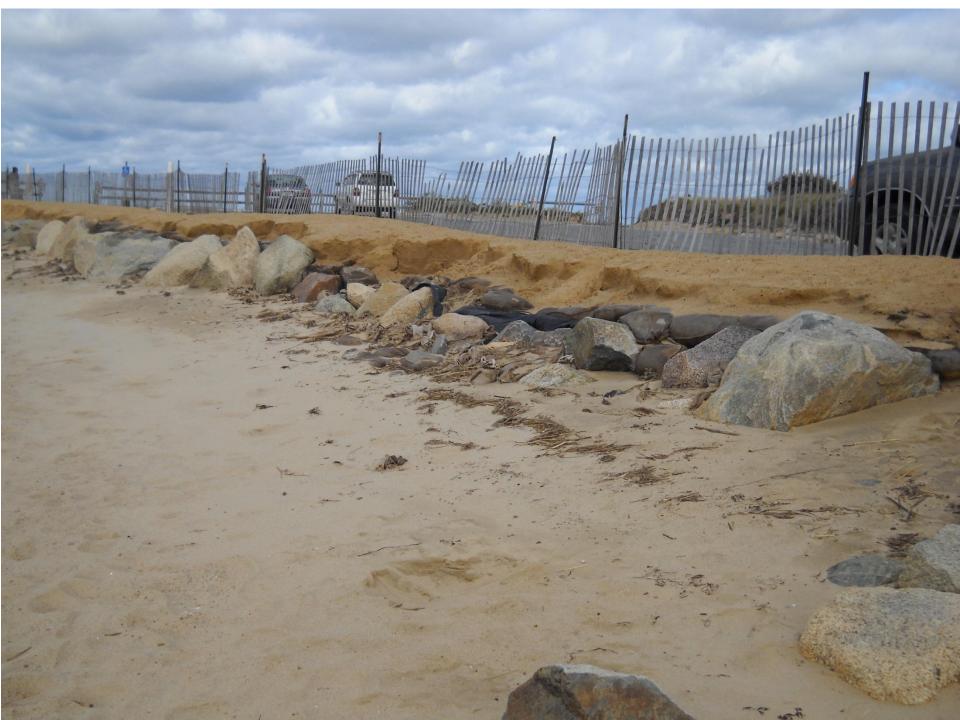
2011

- Repeat of 2010, with extensive damage to parking area, loss of pavement and asphalt fragments throughout beach and creek.
- AmeriCorp helps install another 1,000 sandbags to shore up area.
- Very short term repair, additional damage in spring.

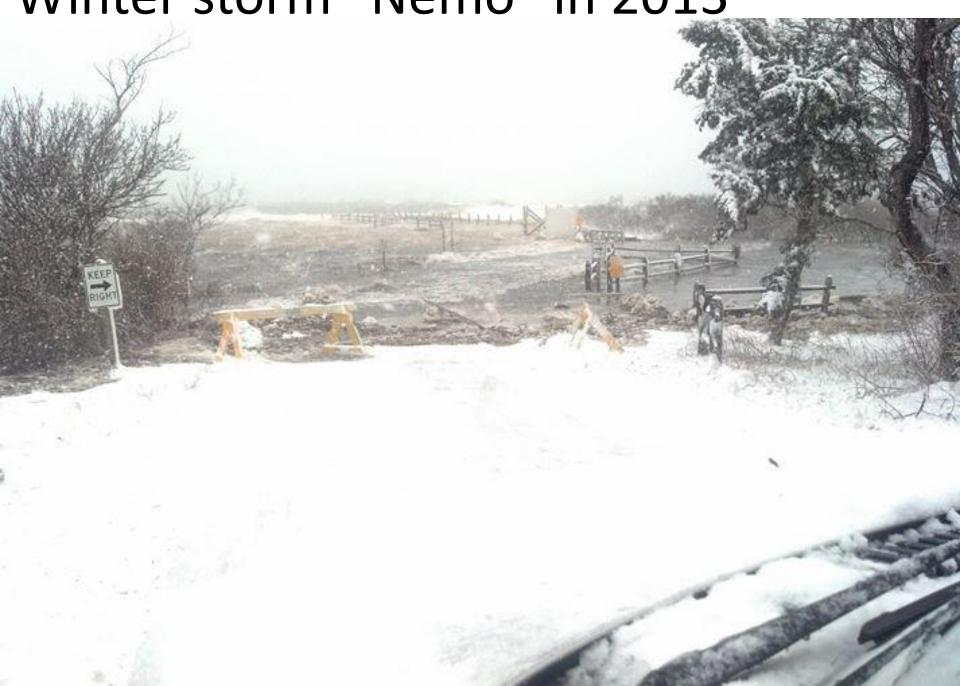
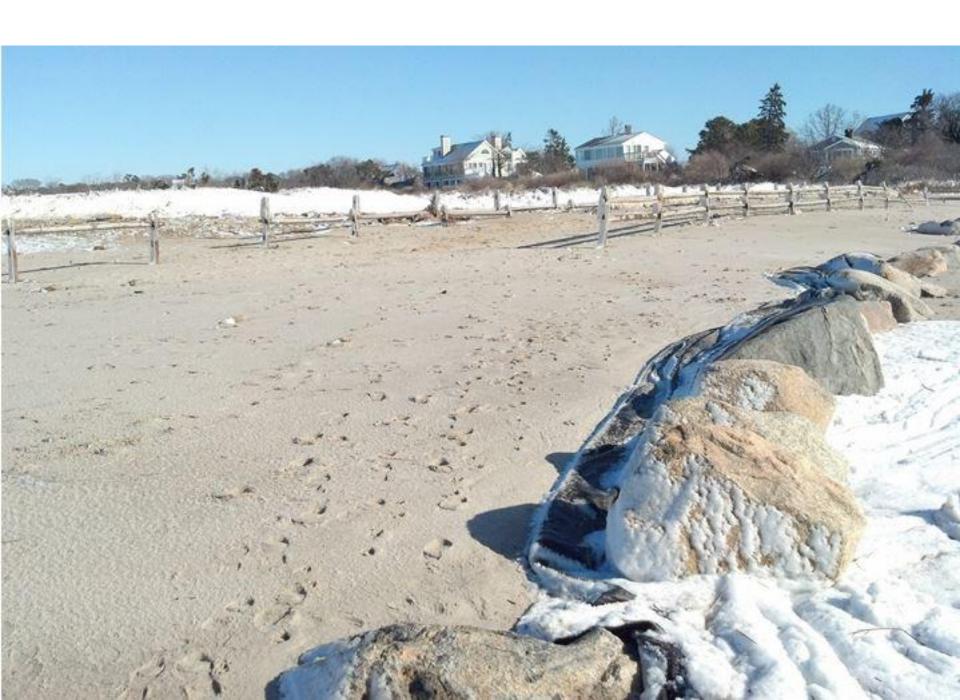
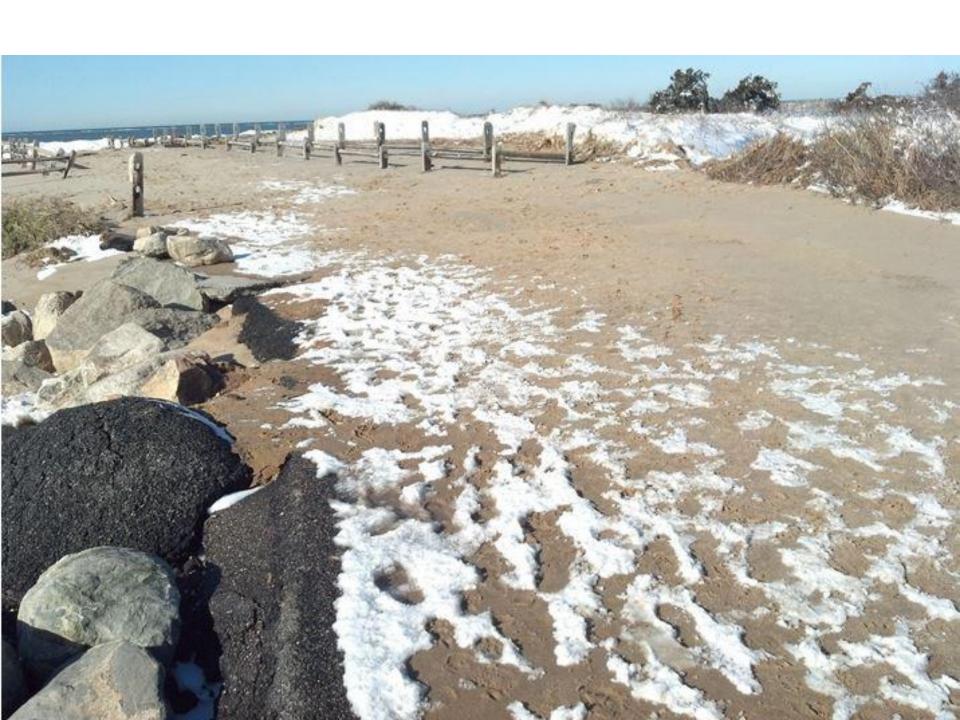
Winter storm "Nemo" in 2013

- Since parking lot retreat, several severe storms.
- Old parking lot would have likely suffered extensive damage, if not completely destroying it.
- Restored area lost a lot of beach sand.
- New parking area inundated but minimal damage.

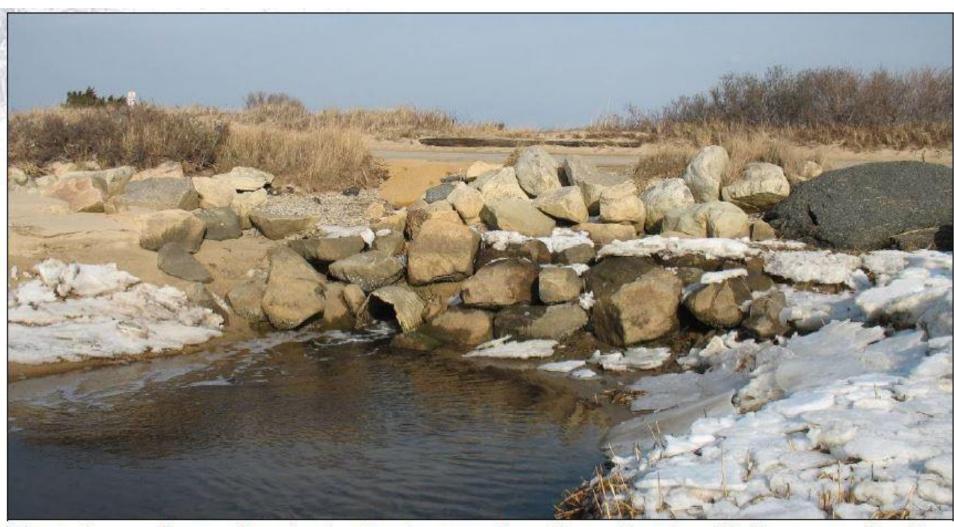
Freemans Pond Culvert

Figure 9. Seaward end of culvert connecting Stony Brook with Freemans Pond showing deteriorating embankment protection (photo taken January 23, 2009).

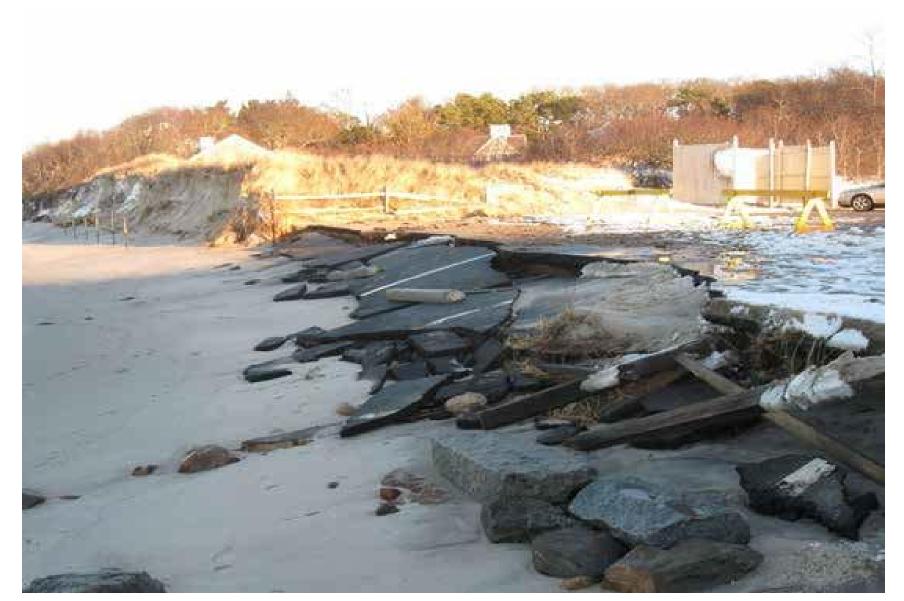
Breakwater January 3, 2010

Winter storms removed remnants of dune north end of parking lot, causing the lot to be undermined. January 2010, sand was placed to provide additional protection for the remainder of the winter. The sacrificial dune was destroyed; additional parking area was lost. The parking lot elevation is low, and unless protected, we may expect additional loss of pavement each year, in part due to the lack of sediment transport from further west (revetments and groins).

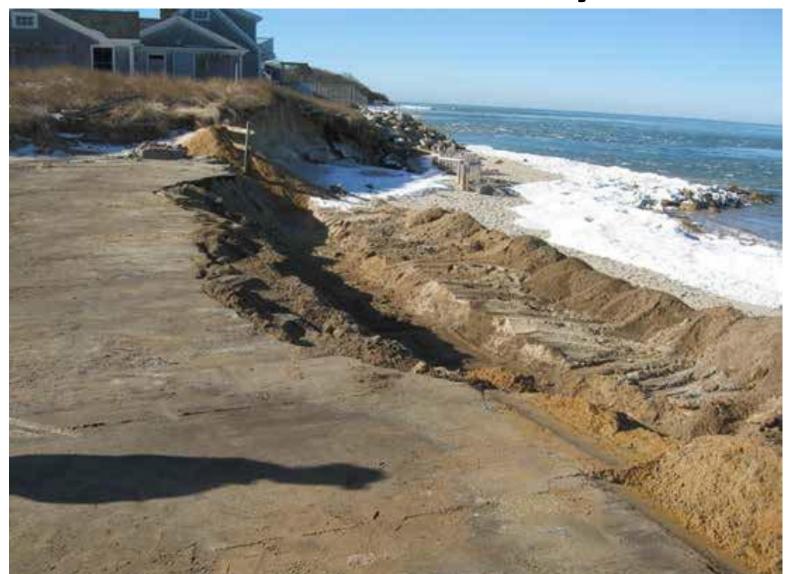
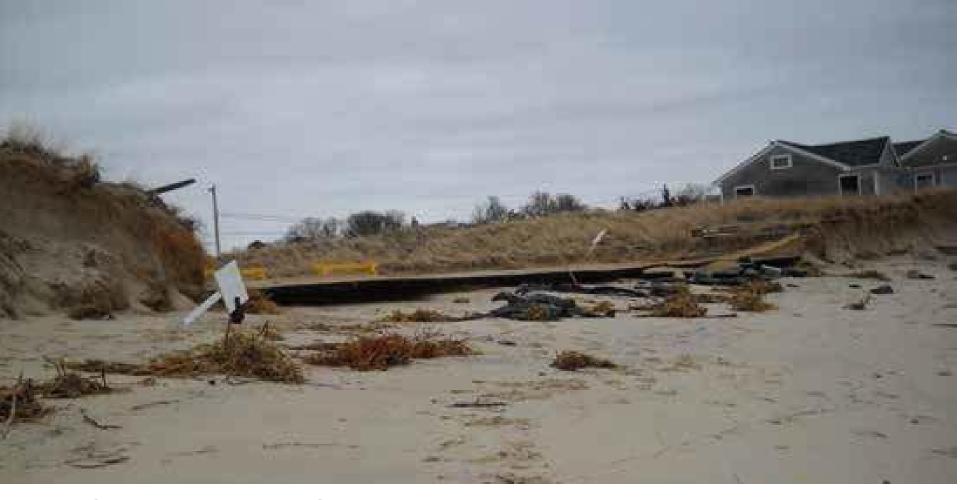
Breakwater – Rebuilding/replacing the artificial dune in January 2010

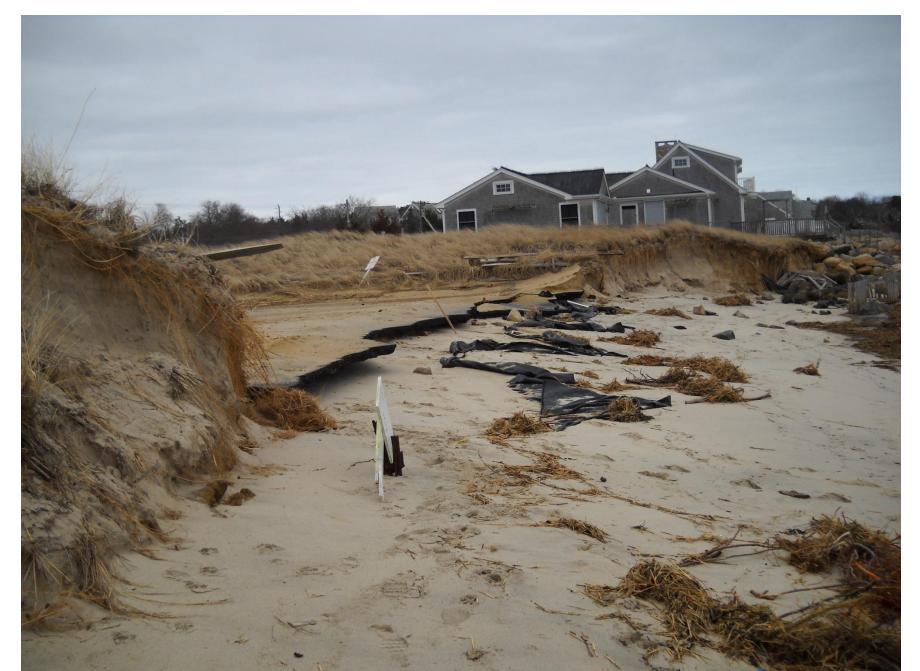
Breakwater March 2010

Stormwater currently collects in the northwest corner of the lot, causing erosion of the dune as it moves north onto the beach. At times this forms a deep very large puddle, forcing a hole through the dune over time. The grant proposal would eliminate the direct stormwater discharge onto the beach, reduce the volume of stormwater generated, and treat the stormwater through natural bio-swales or porous pavement.

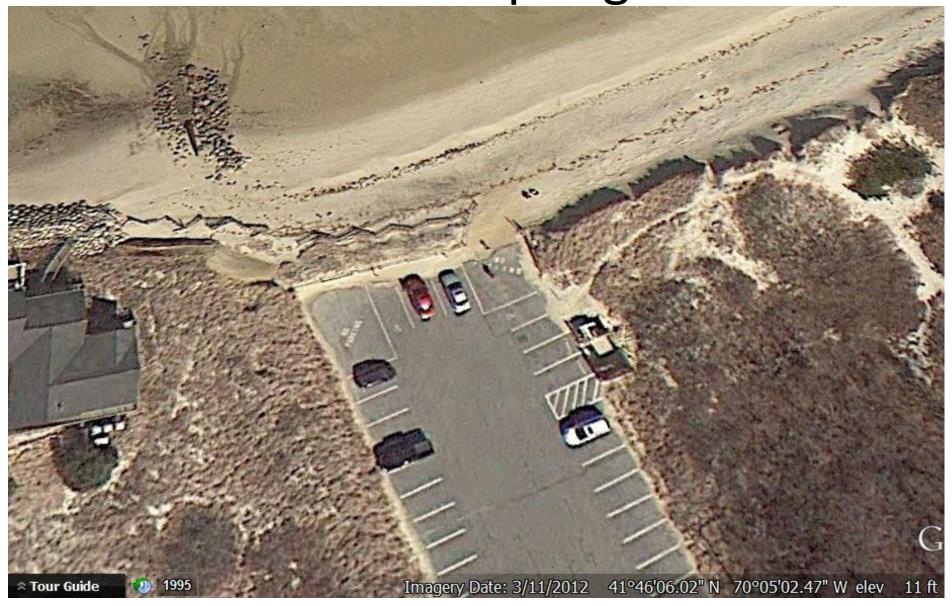
March 26, 2014

Storm left debris, wrack and eroded sand from base of dune at sturdy sand fence located at north end of parking lot at Breakwater.

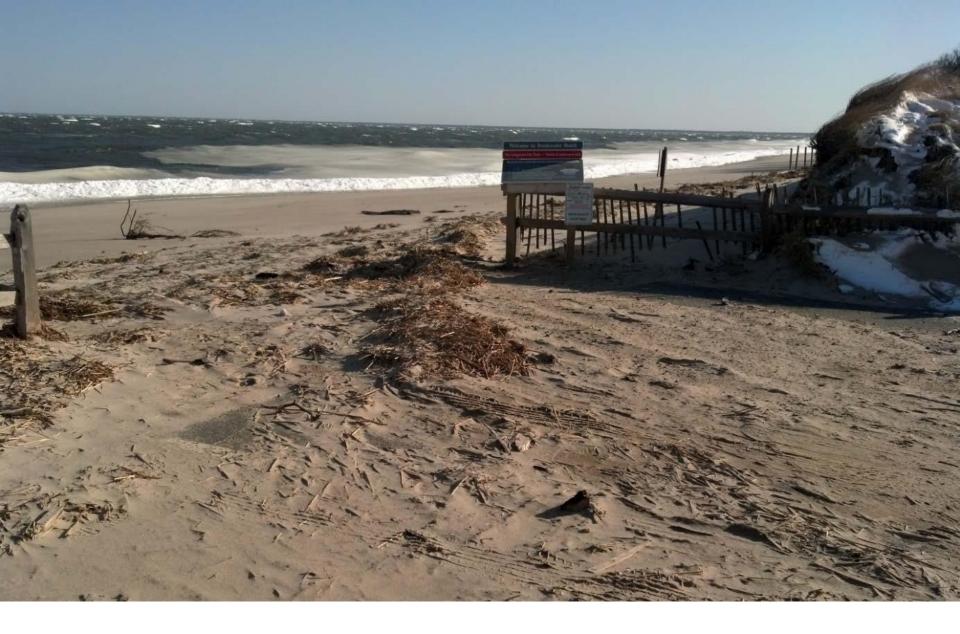
March 26, 2014

Storm left wrack and wind and wave born sand into paved parking area at Breakwater.

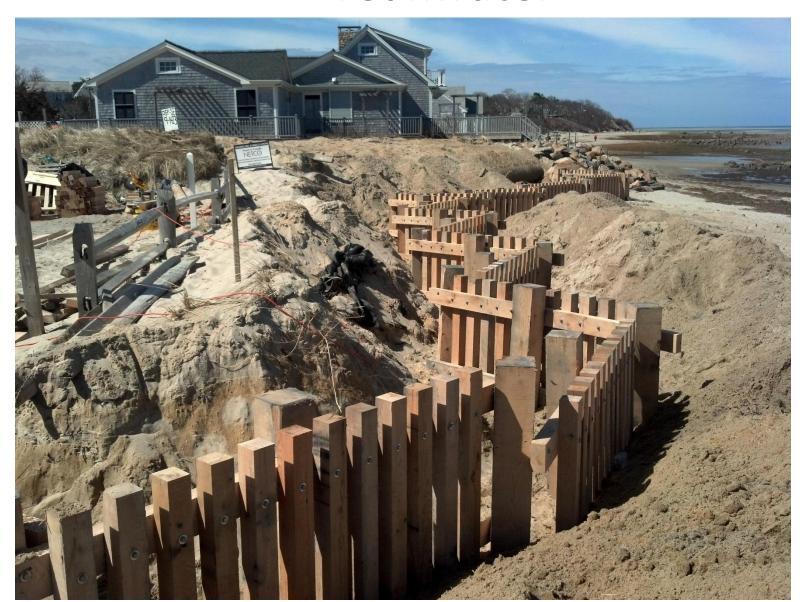
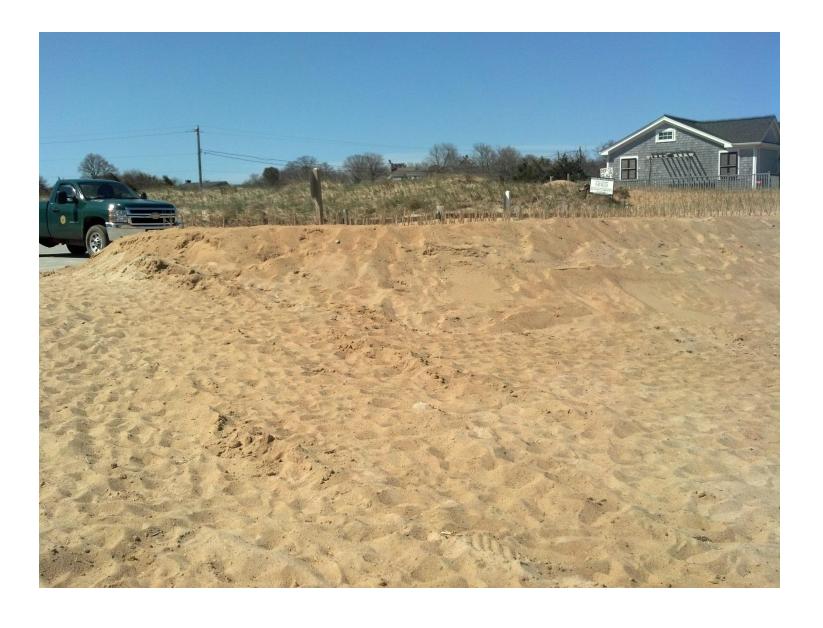
Sturdy sand fence in sacrificial dune at Breakwater

Sturdy fence buried under new dune located slightly further from active beach.

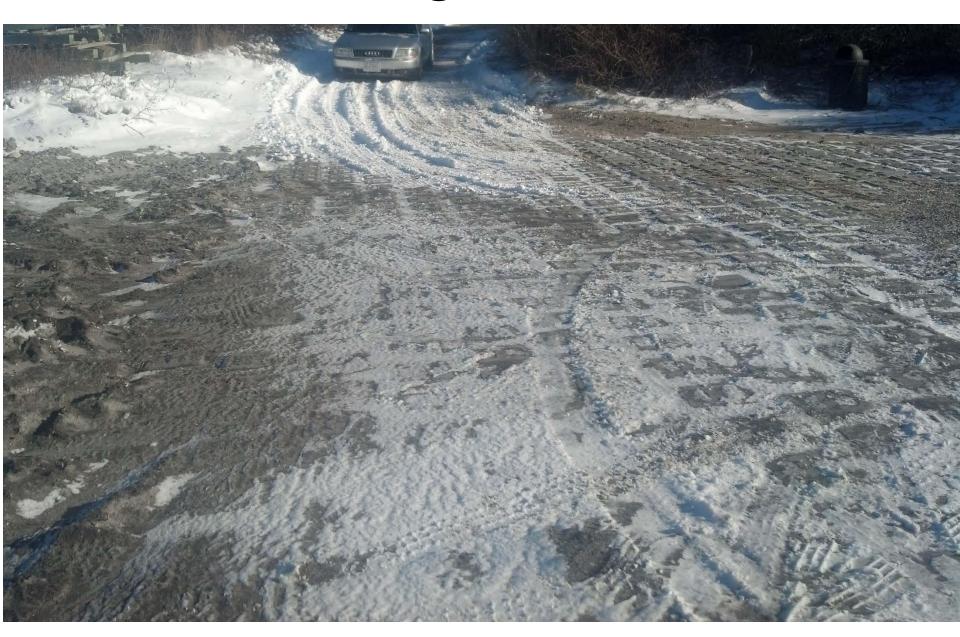
Articulating concrete mat

Blocks connected with flexible cable

- The paved parking area at Mant's Landing Beach is located in a dune at a very low elevation, and suffers from repetitive storm damage.
- Use of a removable flexible articulating concrete mat as an interim replacement for a paved parking area on a beach until a permanent solution can be found.
- Raise grade at rear of property to lessen flooding

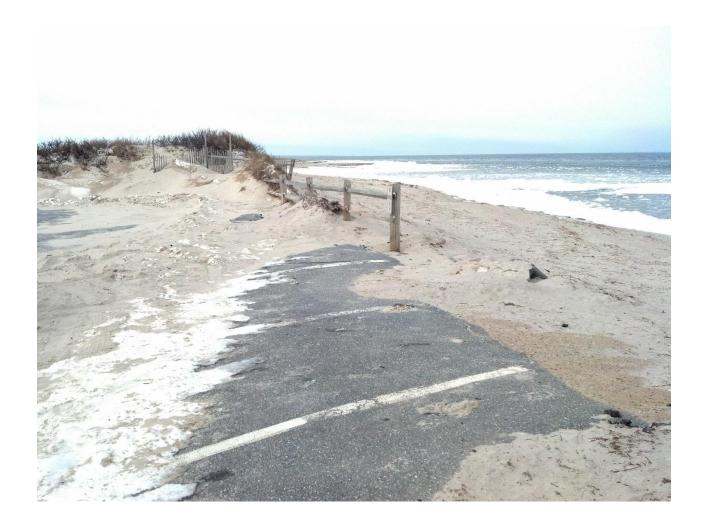
January 2013 Mants

Winter storm removed sacrificial dunes. Rebuilt in early February 2013.

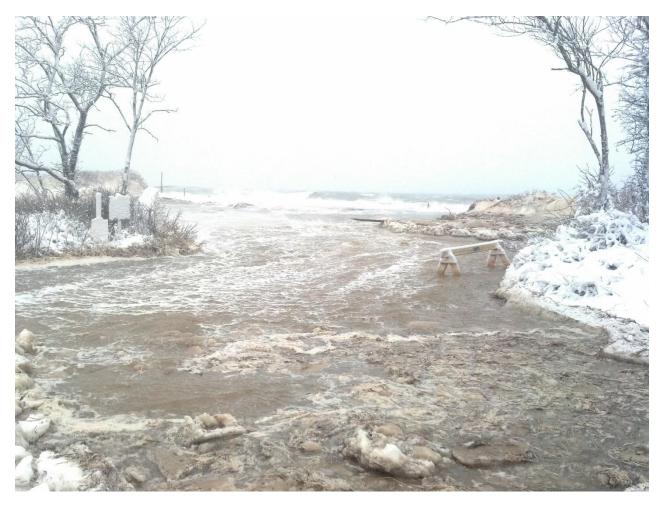
Mants February 2013

Nor'easter Nemo. Dunes destroyed, parking lot asphalt lifted and damaged.

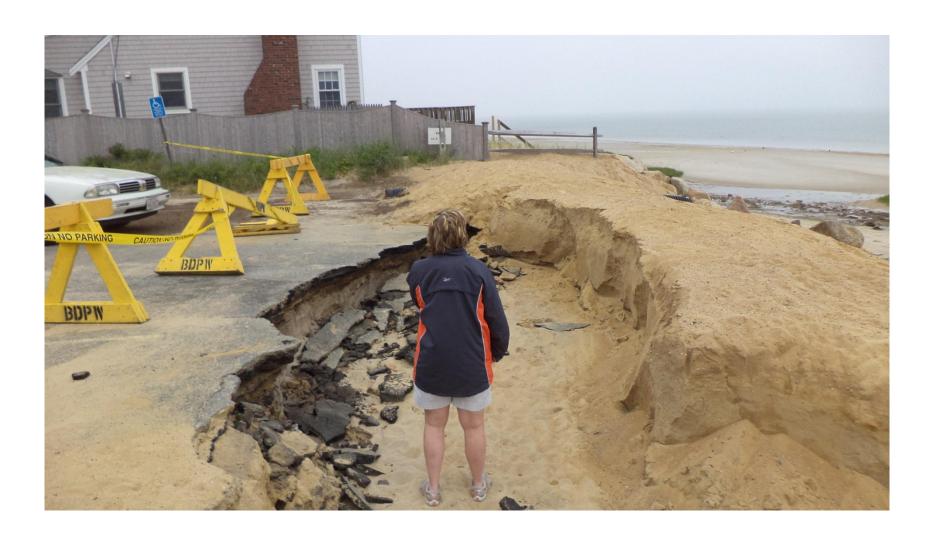
Ellis May 2012 stormwater

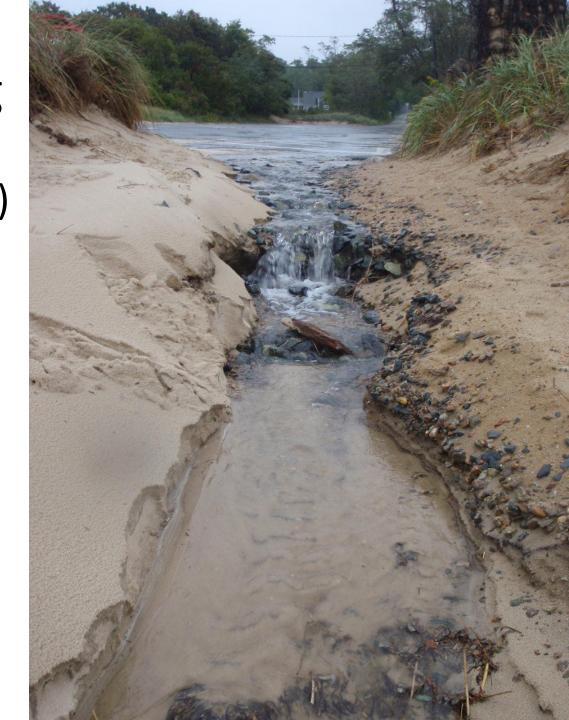
Linnell Landing

Stormwater (rain) discharges directly to beach
